THEME: CONDENSER MECHANICAL DAMAGES

REDUCED SYSTEM PERFORMANCE

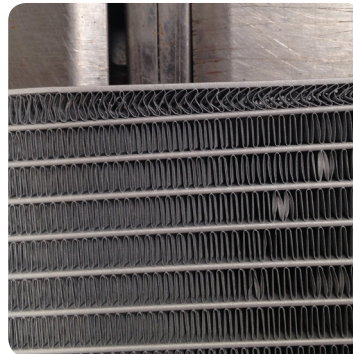
Transport damages – The thin aluminum, which the condenser is made of, makes the construction fragile. This requires handling with significant care. Throwing the condenser box, or improper handling during installation, will quickly spoil the fragile parts. Even small surface dents or seemingly light bends can impair or limit the condenser inner flow, thus reduce operation capacity. Other areas exposed to mechanical damages are mounting brackets and connection sockets

Bent top tube by improper product handling

Always handle the condenser with proper care and do not disregard any light damages on its surface. If the tubes and/or fins are visibly damaged, replace the condenser with a new intact unit.

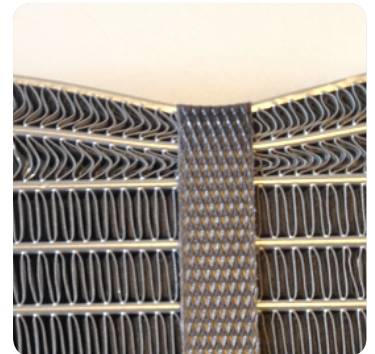
Poor quality packing – Too tight condenser strapping inside the box will often crush its top and bottom tubes. As the tube is flat, with a small diameter, the flow in a crushed tube will extremely be limited or completely disabled. Furthermore, most of modern condenser tubes are produced in so called microtube design and with inner partitioning walls, making them very sensitive on bends or crushes.

Top tubes bent by too tight strapping

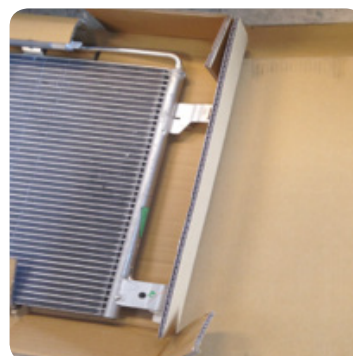
Poor quality packaging cannot ensure a proper damage protection during transportation and storage
